Ref: Harris Center for mental Health and IDD (formerly known as MHMRA of Harris County)
612 Branard Street, Houston TX 77019

On December 15th & 16th, 2016, a representative from Dawson Van Orden visited the property at the above referenced address to perform a structural assessment of the five (5) existing structures. The purpose of this investigation is to identifying any major issues that would reduce the life of the structures over the next 25 years. Items include:

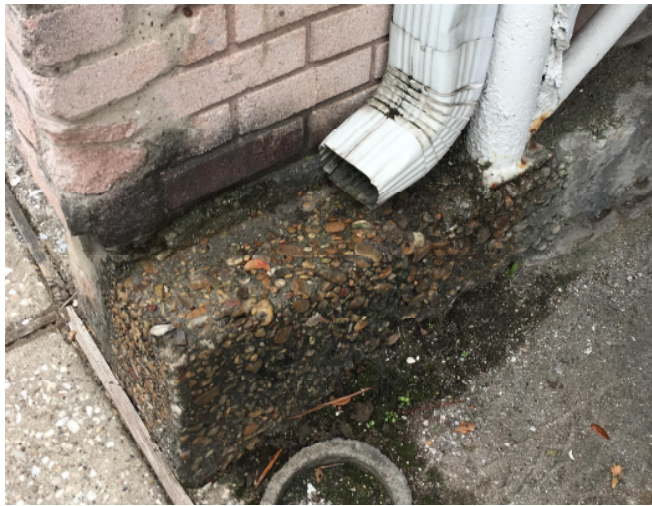
All in all, the foundations for all structures appear to be in good shape and show no major signs of distress. Minor cracks and spalling of some corners were observed along the building perimeters but none appear to detrimental to the adequate support of the structures above. Two areas that need to be noted are the South-East and South-West corner of the building. At these locations, the gutter downspouts have been placed such that they are resting on top of the continuous concrete curb that supports the southern masonry wall (Photo 2 and 3). To this point, it is our opinion that no structural damage has been done to the concrete foundation or the adjacent steel x-brace. Over time, the rush of the water exiting downspouts has weathered the concrete to the point where top layer has been removed and the concrete aggregate is now exposed. The water has also most likely helped contributed the minor rusting of the steel x-brace and base plate. Along the east side of Building 2 there is some minor grading issues but that will be discussed later in this report in the "Recommendation" section.

Photo 2 – Southeast Corner of Building 3 Foundation

For the foundations, DVO recommends the downspouts at the South corners of Building 3 be relocated to in a manner to which the exiting water does not contact the existing concrete curb and runs away from the buildings foundation. This will insure that no accelerated weathering to the foundation elements will occur. The foundation exterior of the foundation should then be patched.

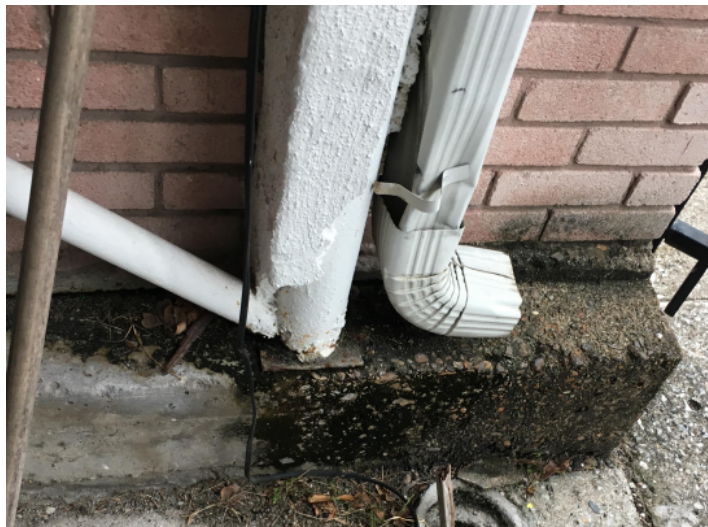
Photo 3 – Southwest Corner of Building 3 Foundation

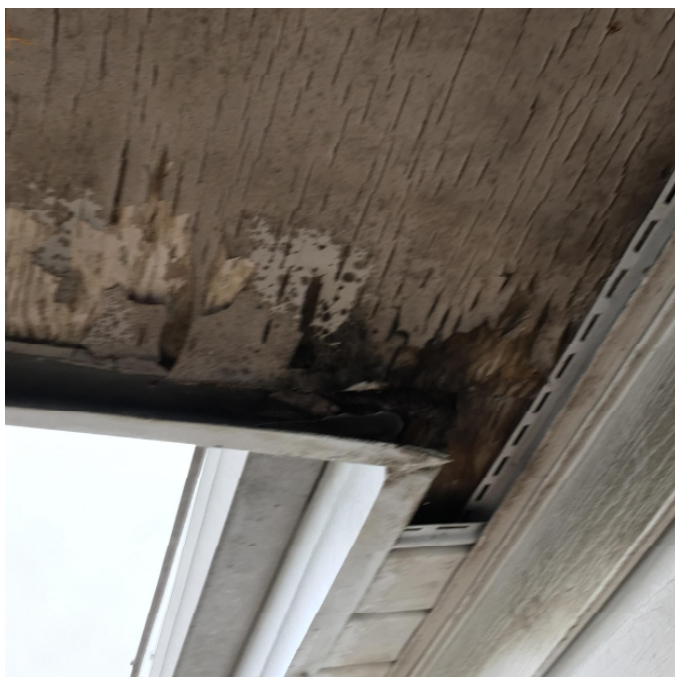
In several locations along the exterior overhang in Buildings 1 and 2, the plastic soffit was removed for closer inspection. It was found that almost all of the plywood soffit sheathing was rotted and completely deteriorated. The joist however, only exhibit minor surface damage. The following photos is somewhat deceiving as the tar used in the roof assembly seeped down on the side of the joist. The soffit was not removed from Building 3 as there were no visual signs of damage from the exterior.

Photo 5 – Condition of Soffit on Underside of Roof Overhang

Under the exterior overhang, we recommend that all of the soffit board should be removed and replaced for Buildings 1, 2 and 3. Furthermore, the continuous fascia along the perimeter of the overhang shall be further inspected and replaced if necessary. Most of the roof joists were found to be structurally sound. The ones that were not need to be replaced. DVO estimates that 75% of the joists are acceptable to be left as is.

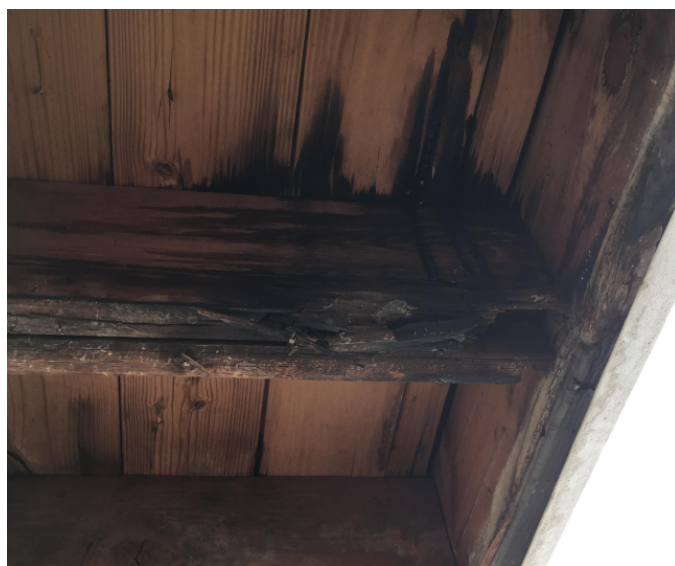
Photo 6 – Extended Roof Joist at Overhang

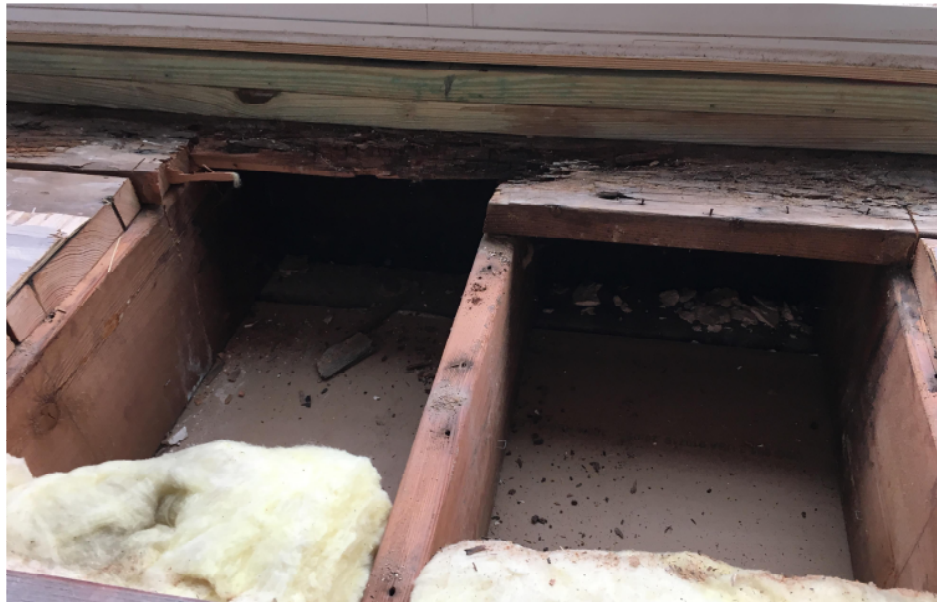
The floor assembly for Buildings 1, 2 and 3 are in good condition with no signs of cracking on the ceiling on the underside the first floor. In several areas, the unit floor material has been loosened over time but there are no signs that the floor sheathing has been damaged. One exception is at several window casings. In unit #6 in Building 1, water has infiltrated the window casing over time and has rotted bottom plate and small part of the floor decking. The bottom plate has since been replaced. The extent of the damage appears to stop there. The corrosion on the floor joist and the top plate below appears to be on the surface only.

Photo 7 – Floor Framing at Window Sill in Unit #6

At this time we do not believe that any action needs to be taken in regards to the interior floor framing. In unit #6, the existing penetration in the floor can also be resealed. We also recommend that the planks at the exterior elevated walkways have their current paint removed a new protective paint or sealant be applied. One side note is that while on site, DVO was informed that corrosion to structural members around the bathroom tub area on previously remodeled units was discovered. We believe this should be further investigated in the other units and action taken if found that any additional corrosion exists.

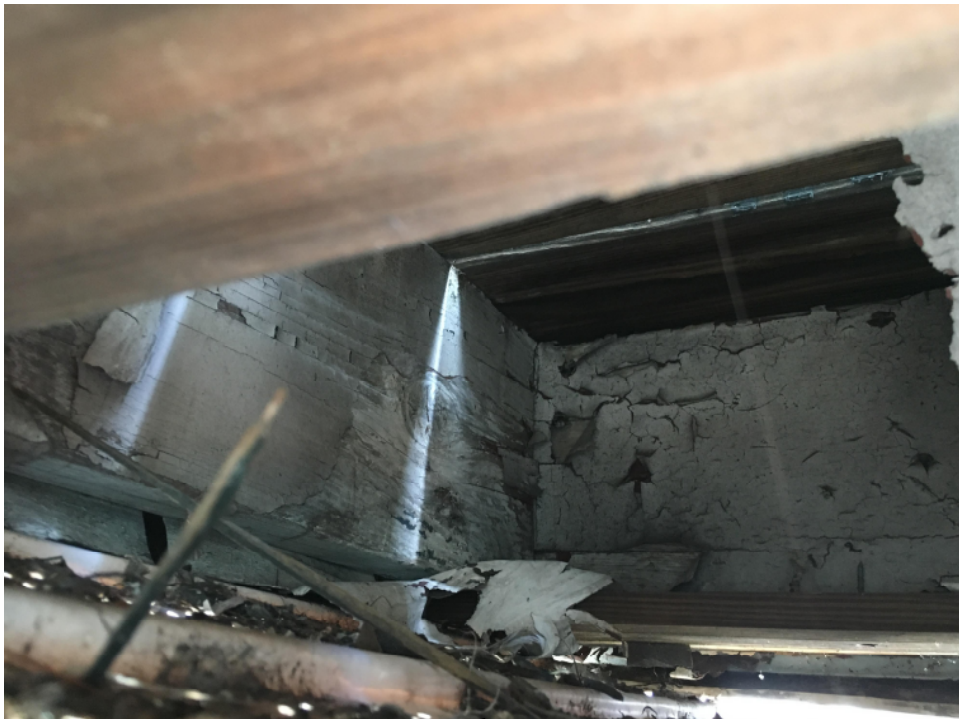
Unlike the roof overhang, the soffit underneath the 2nd floor cantilevered walkway only consists of a perforated covering. This is to allow for proper drainage as water is able to penetrate through deck planks above. The condition of the joist themselves is fair. A protective coating has been previously applied to all the walkway members but the coating is extremely deteriorated. The joist themselves do not show any signs of rotting or further corrosion past the surface. The floor planks also are in moderate condition and show expected wear from continuous foot traffic on them.

Photo 8 – Framing of 2nd Floor Elevated Walkway

For the 2nd floor walkway, we recommend that all the soffit material be removed exposing the supporting framing. All the soffit panels shall be cleaned of debris prior to re installation. This will insure water can adequately pass through the assembly and help prevent any future corrosion and damage to the supporting framing. We recommend that all the existing protective coating for be removed from the framing members and a new coating be applied. To further the life of the floor planks on top of the joist, the same shall be done to those members as well.

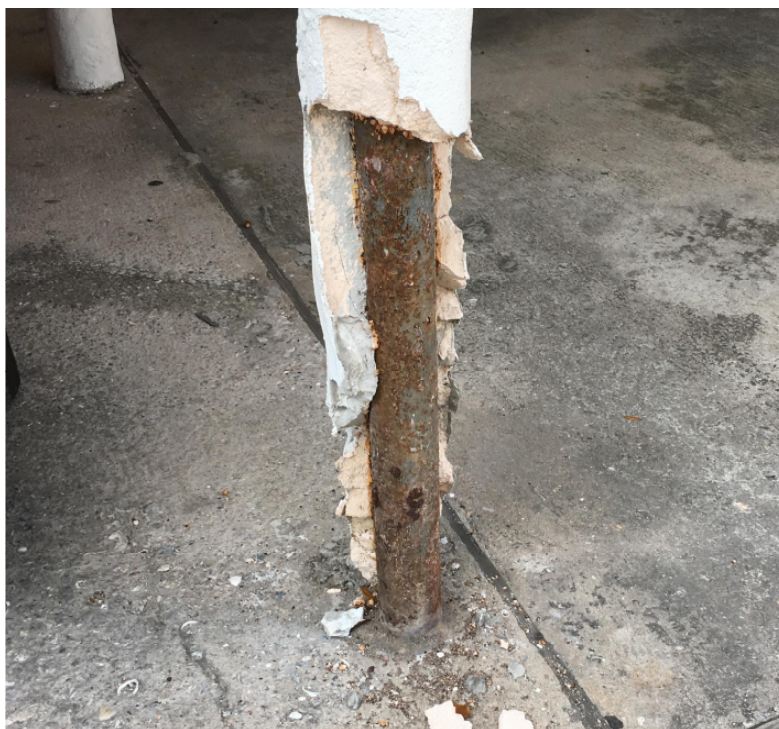
All of the round steel columns, x-bracing members and base plates are covered with a white protective paint. Additional protection has also been provided over the column baseplate and the columns themselves. The thickness nor the exact type of material used could not be verified but is in good condition depending on their distance to the exterior perimeter of the building. The columns near the interior of the structure show no signs of damage or deterioration. However the perimeter columns show moderate to severe corrosion. Photo 9 demonstrates the typical condition of the columns although the others do not have as much column directly exposed. The condition of the bases of the columns at these locations could not be verified. The bases sitting on top of the curb on the interior could also not be verified due to the additional protective layer with the exception of two columns. At the Southeast and Southwest corners of the building, the base plates are exposed and they have had their protective layer removed. This is most likely due to the exposure to water exiting the gutter as previously discussed. For the condition of the columns and base plates at these corner locations, please see Photo 2 and 3. It is of our opinion no damage has been done specifically to the column base plates at this time at these locations. The overall condition of the x-bracing members is good. Only a couple of members exhibit light rusting but no major corrosion can be seen at this time.

Photo 9 – Corrosion of Column at Building 3

At the South corners, we recommend that the existing corrosion be removed from the column baseplates and a new protective coating be applied. If the owner desires, the additional protection that has been removed can then be reapplied. For the perimeter columns, it is recommended that all the additional protective material be removed from the columns along their entire height. Any corrosion that is present shall be removed and a new protective coating shall be applied. Similarly to the corners, if the additional protection is desired that shall also be reapplied. It should be noted that the depth or severity of the corrosion should be monitored during its removal. If too much of the column may need to be removed, the entire column may need to be replaced. We also recommend removing the additional protective layer from at least one interior column to further investigate if the any interior corrosion may be present under the exterior layer. Areas on the x-bracing members where light rust can be seen on the surface shall have those areas sanded down to the raw steel and have a protective coating applied.

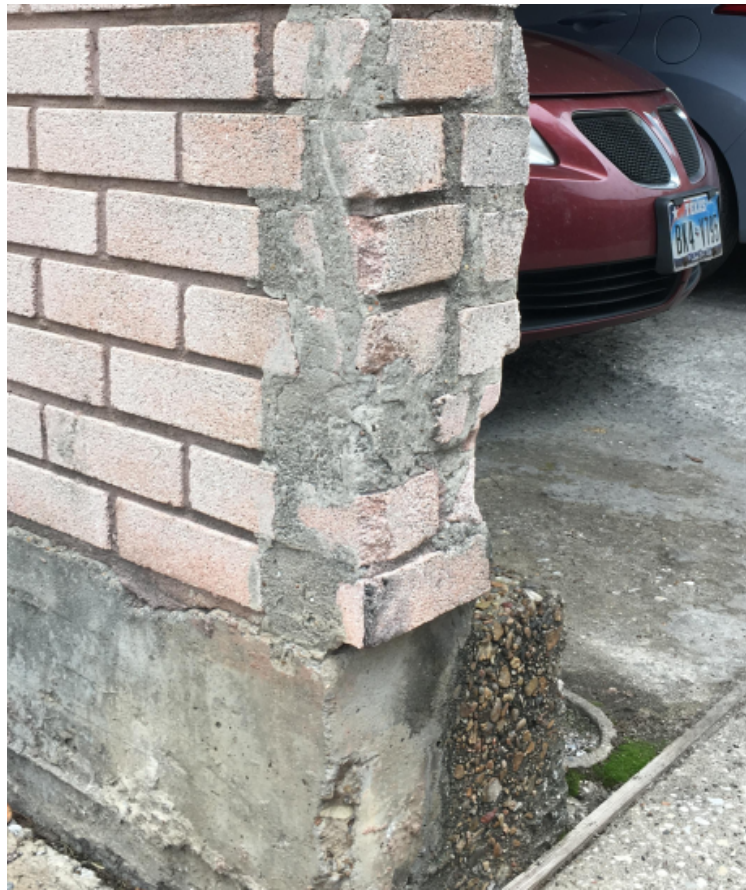
Overall the brick façade is in good condition as well and shows normal signs of wear. If looking up close, minor cracks in the grout can be seen in almost all the walls and in particular around the windows however we believe this to be normal for buildings of this age. Previous repairs in several areas are visible, most notably at the Southeast corner of Building 3 and the South face of Building 1. At the corner of Building 3, the face of the brick façade is offset several inches away from the face of

the concrete support below. This eccentricity of the weight above is most likely the cause for issues in this area.

Photo 10 – Spalling of Brick on Southeast corner of Building 3

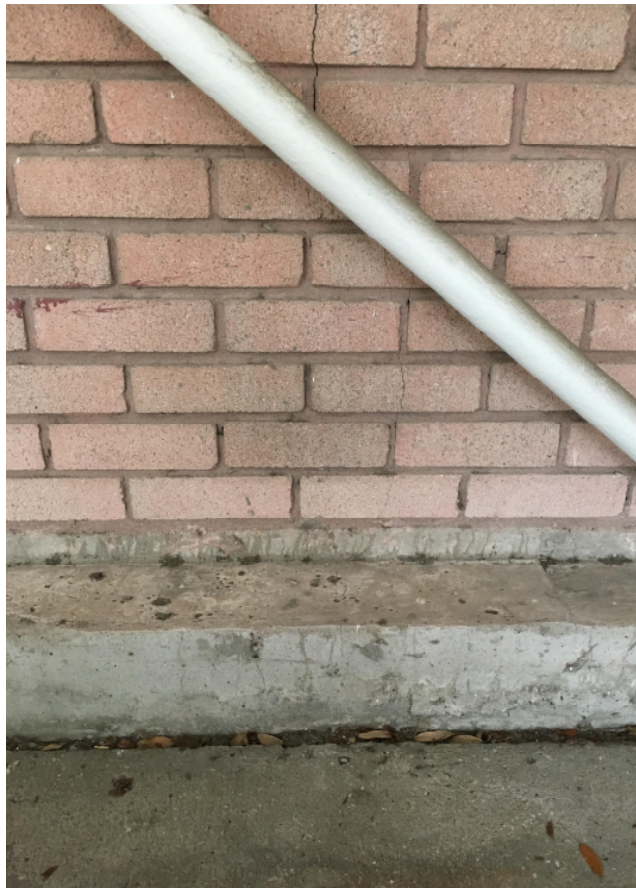
Approximately halfway down the length of the central wall in Building 3 a major crack is apparent. The crack starts at the foundation and continues vertically with the crack width expanding as it gets further up the wall. The foundation shows no major signs of distress or any loss of structural integrity. Because of this and no other apparent damage to the surrounding structure, we do not believe this to be a major structural issue. We believe this is simply a product of the structures natural movement and settlement over time.

Photo 11 – Crack in Masonry Wall at Building 3

The minor cracking exhibited in the brick does not need to be repaired at this time. It should though be monitored in the future and repaired if desired by the owner if any crack becomes larger than desired. The façade serves no structural purpose and therefore can be classified as a serviceability item. To prevent any further corrosion on the steel lintels, DVO recommends that the existing paint removed and new paint be applied.

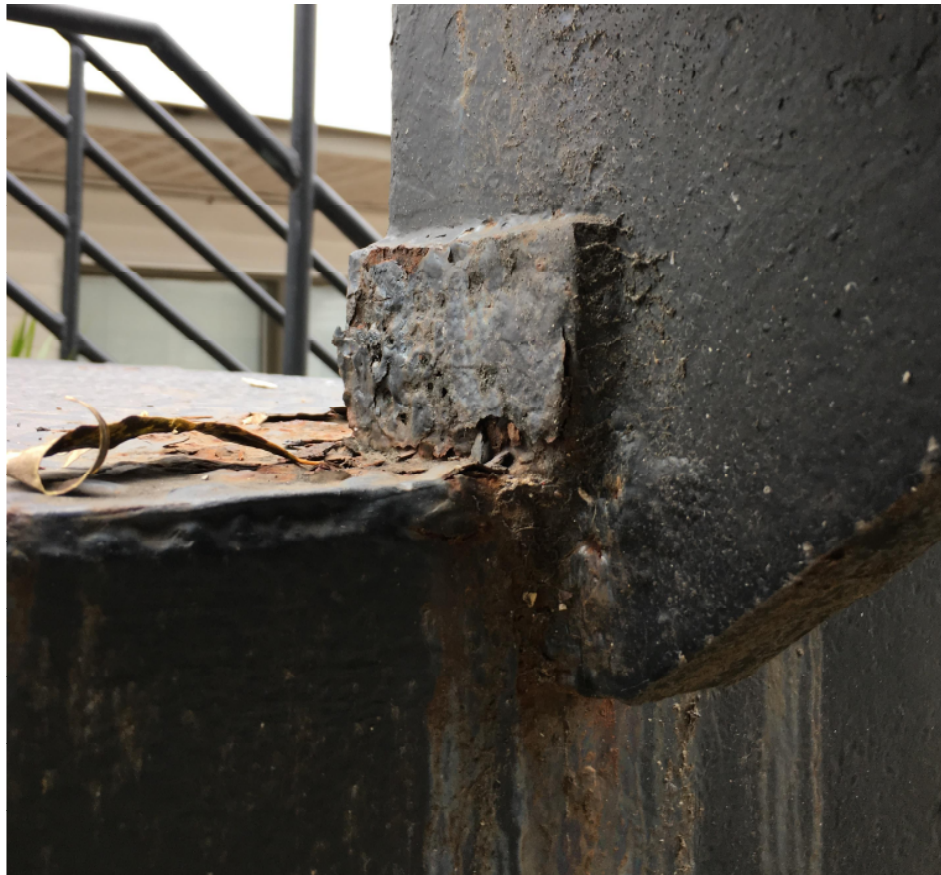
As a whole, the steel stairs are in moderate condition. For the rear stairs servicing Buildings 1 and 2, the welded connections exhibit rust in many locations. Some connections appear to be minor while others are more severe. This includes the connection of the railings to the stringers, the connection of treads to the stringers, the stringer connection to the mid landing as well as the mid landing assembly. The base of the supporting columns and lower stringer to the finish paving visually exhibits a great amount of corrosion. As previously discussed, the exact attachment to the foundation/supporting element below cannot be confirmed so the determination of the extent of damage is difficult at this time. The plate at the bottom of the mid landing support columns is severely deteriorated. The front stair servicing Building 3 is in better condition although minor rusting and corrosion on many of the same elements is still present. Although the exact material used for the railings could not be fully verified, the spacing of the vertical attachment members and their diameters are typical to what is commonly installed in accordance with the 2012 IBC codes. The height of the railing also meets the code minimum.

Photo 12 – Connection of Stair Stringer to Mid Landing

To prevent any further damage to the steel for both stair cases, we recommend that all connections have the existing coating and corrosion be removed down to bare metal. A new protective coating shall then be reapplied. At approximately half the stringer to mid landing connections, the corrosion is

severe and therefore, we recommend that an additional clip be added prior to applying the new protective coating.

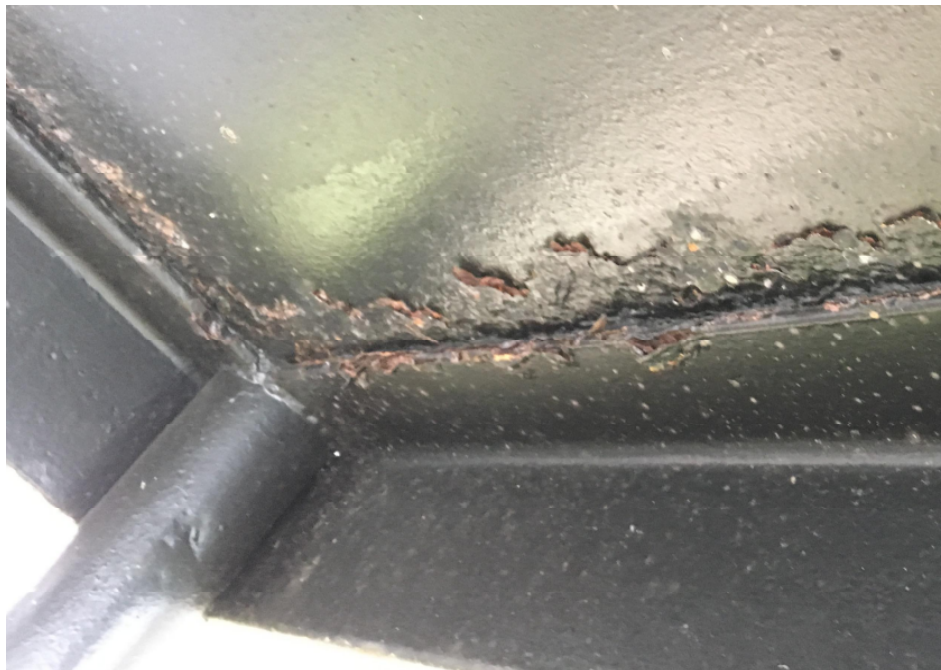
Photo 13 – Corrosion on the Underside of Rear Mid Landing

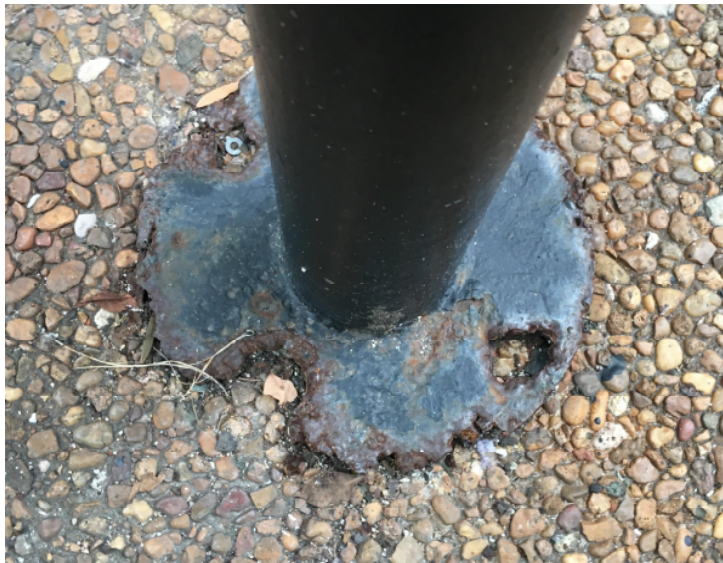
Photo 14 – Corrosion of Rear Stair Baseplate

For the rear staircase servicing Building 1 and 2, further investigation needs to be completed to determine exactly what the existing support system is at its base. It is our understanding much of the existing paving will be removed in the courtyard area allowing for an opportunity for a proper investigation to take place.

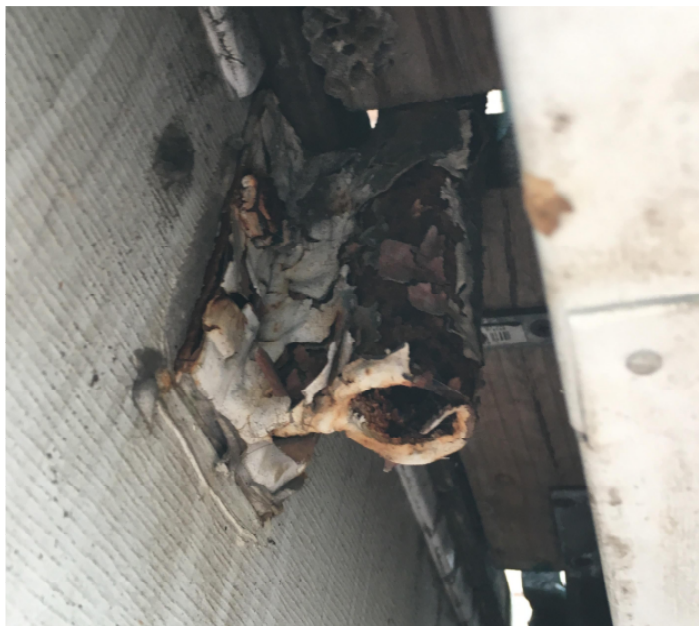
The railings above the elevated walkway are in good condition. The 2x member making up the top railing is in disrepair for the majority of its length but the remaining areas show no signs of damage. The steel pipes and the interior of the wood framing are protected by a green paint that has adequately protected the members. Calculations using the minimum load requirements from the 2012 IBC show that the minimum embedment length of the lag screw through the vertical/horizontal pipes into the 2x wood framing needs to be 1.92" (assuming SYP lumber). The length of the lag screws could not be verified visually however with the 2x member only being 1-1/2" thick, it is probable that this minimum length has not been met. Below the deck the conditions of the framing members are dismal.

Photo15 – Deteriorated Connection Railing to Elevated Walkway Fascia

Approximately 50% of the steel clips used to attach the vertical railing members to the exterior are in disrepair. As seen in Photo 15, the paint protectant has not adequately held up to the constant exposure to the elements and the steel is now corroding. Similar to the knee wall connection, the attachment anchors at the base could not be verified.

For the 2x knee wall, only minor repairs need to be made. Those repairs include completely replacing approximately 75% of the top railing, striping the paint off the remaining the other areas and repainting and replacing the siding along the front face of the railing at the Southwest corner of Building 2. As previously discussed, the current attachment of the knee wall does not appear to be adequate to support minimum code loads. Therefore additional brackets will need to be installed at the attachment location. Because of the tight spacing between the face of the railing, it is recommended that the wood exterior piece of the railing be removed for closer inspection of both the steel railing attachment brackets and their connection to the perimeter fascia board. We anticipate that half of the brackets and most of the anchors will need to be replaced. For the remaining half, the existing protective coating any corrosion will need to be removed and new protective coating will need to be reapplied. This also applies to the brackets that attach the railing to the side of the buildings.

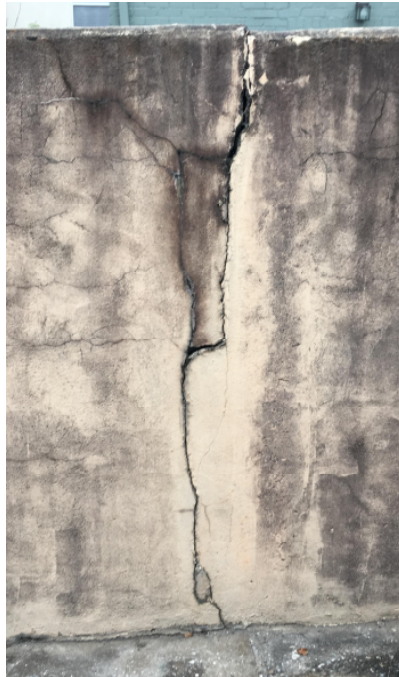
Along the West property line, south of the Gym Building, a continuous concrete retaining wall is located. The wall is approximately 8-1/2" thick and 82" tall. Multiple vertical and horizontal cracks are present in the wall along its length. The most notable crack is located roughly halfway down the wall's 50 foot length. The width of the crack varies but is consistent from the bottom of the wall to the top and represents a complete shear failure in the wall. Similar to the brick façade, there is no expansion joint located along the wall. Typical practices today suggest that joints should be implemented every 25 to 40 feet. This allows the wall to be able to shift, move more freely when exposed to temperature variations as well as slight shifts created soil by movement, shrinking and heaving. The levelness of the wall was checked along its entirety using a bubble level and it was found that the wall is vertically flush throughout.

Photo 16 – Major Crack in West Perimeter Wall

Any repairs made to wall are should be considered for serviceability and aesthetical reasons. As previously discussed, the wall is straight along its entire length. Because of this, the existing cracks are due to a variety of reasons, none of which are structural failure. Similar to the roof ponding scenario, we recommend consulting with a general contractor to explore the most cost effective method of repair for the purpose of achieving the owner's final requests.

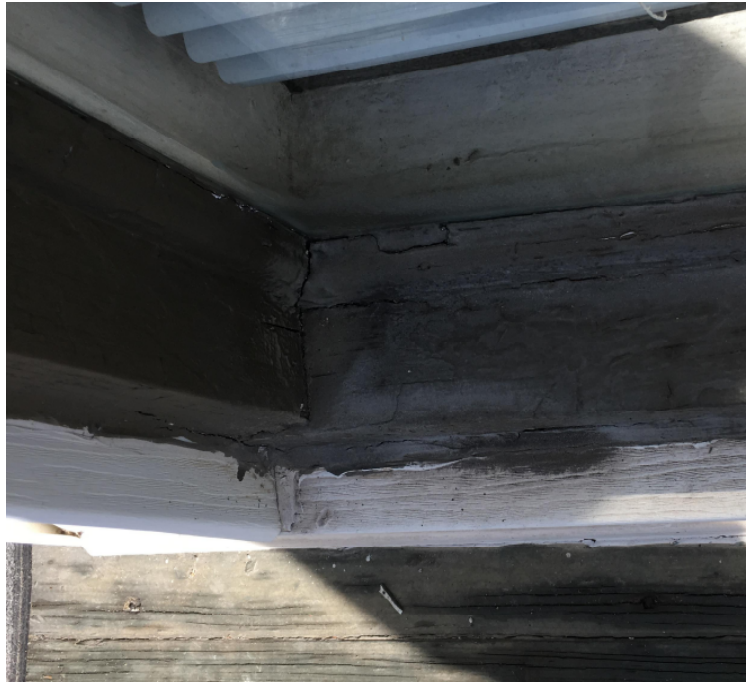
At the brick façade locations all window casings appeared to be in moderate condition. The condition of the casings and sills at the siding locations varied greatly depending on their exposure to the elements. The casings that have been directly exposed to the weather are in moderate condition. Several of the existing wood casings are showing initial signs of cracking at the perimeter seals. The casing in the worst condition is the most southern window on the 2nd floor of Building 2. At this

location, the seals appear to be broken thus allowing potentially allowing water penetration from the exterior. Refer to Photo 17 for further reference. A previous investigation of the wood framing below the sill showed dry rot the bottom plate directly under the window in unit #6. The sill plate has since been repaired. The casings and sills that are covered by the extended roof and or elevated walkway are in moderate condition most likely due to the minimal exposure to the elements.

Photo 17 – Major Crack in West Perimeter Wall

As previously discussed, the window casings that are subjected directly to the elements all show signs of cracking and deteriorations. We therefore recommend at these locations that all existing seals be removed and new sealing be applied. These locations include the most southern windows on the 1st and 2nd floor at Building 2 and the windows along the first floor of Building 1. For the remaining windows, no action is needed at this time however they should be checked periodically and fixed accordingly in the future.

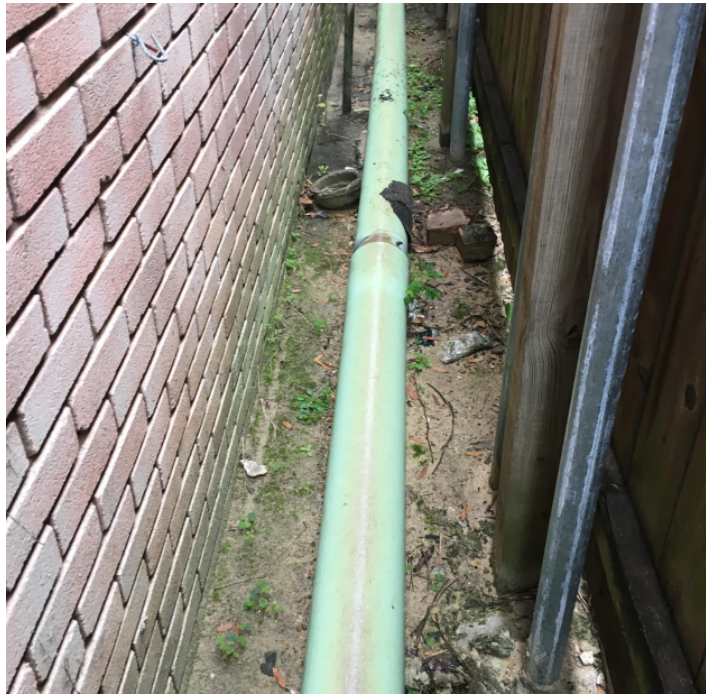
One final observation worth noting is that along the rear (East side of Building 2) face of the structure, the grade has been eroded in a way that currently the water is running towards the structure in many places. There is a large PVC pipe that runs parallel to the structure and the elevation of the grade between the pipe and building foundation is lower than the soil on the opposite of the pipe thus creating an area for any water to pond in a rain event.

Photo 18 – East Perimeter of Building 2

The re-grading of the soil at the rear of Building 2 shall be done immediately. Although difficult to see in Photo 18, the soil on the left side of the pipe sits at a lower elevation than the soil on the right. This creates an opportunity for water to flow toward the structure and more importantly allows an area for the water to pond around the perimeter of the structure. In summary, this could potentially create a non-uniform moisture profile around the perimeter which can be detrimental to the foundations structural integrity. The reason being that in this region of the country the typical soil makeup is clay which exhibits shrink/swell properties as the soils gains and loses moisture. Thus non uniform moisture can create variance in shrinking and swelling of the surrounding soil and ultimately can create uneven forces that can damage the foundation system.
